## CASE HISTORY

COTTO Tiles  
Thai Ceramic Co. Ltd. (TCC)  
Treating Evaporative Condensers

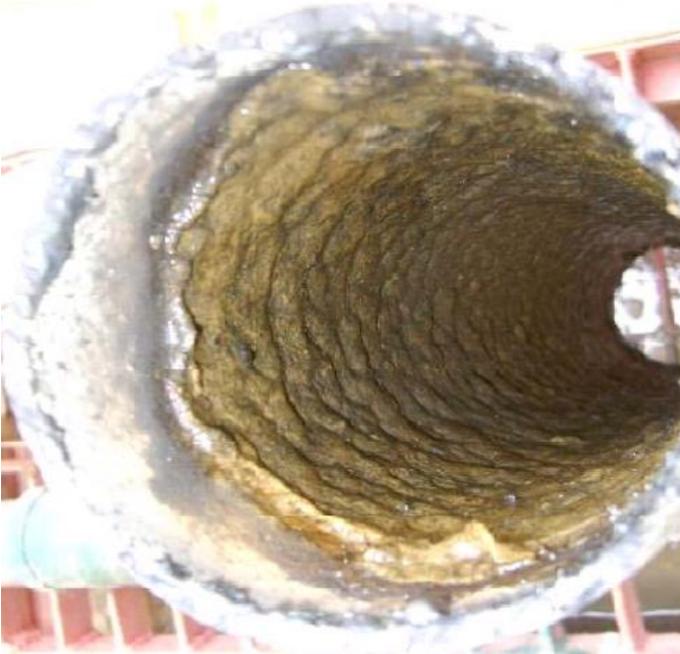
The manufacturing process requires cooling water to be delivered to the molds where the tiles are cast. The water that is used is local towns mains water and has high levels of hardness. Part of the problem was the low flow rate in the pipe line due to heavily scale pipe.

On the left is a picture of the pipe before any treatment took place.

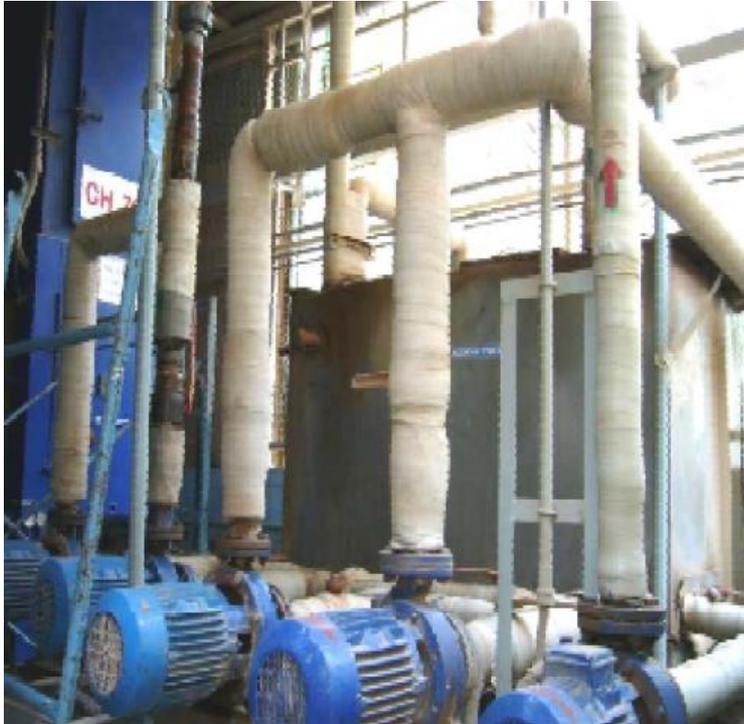
The existing system was already treated by chemicals and a range of other wrap-around and electronic water conditioners had been tried but they had failed to solve the problem.

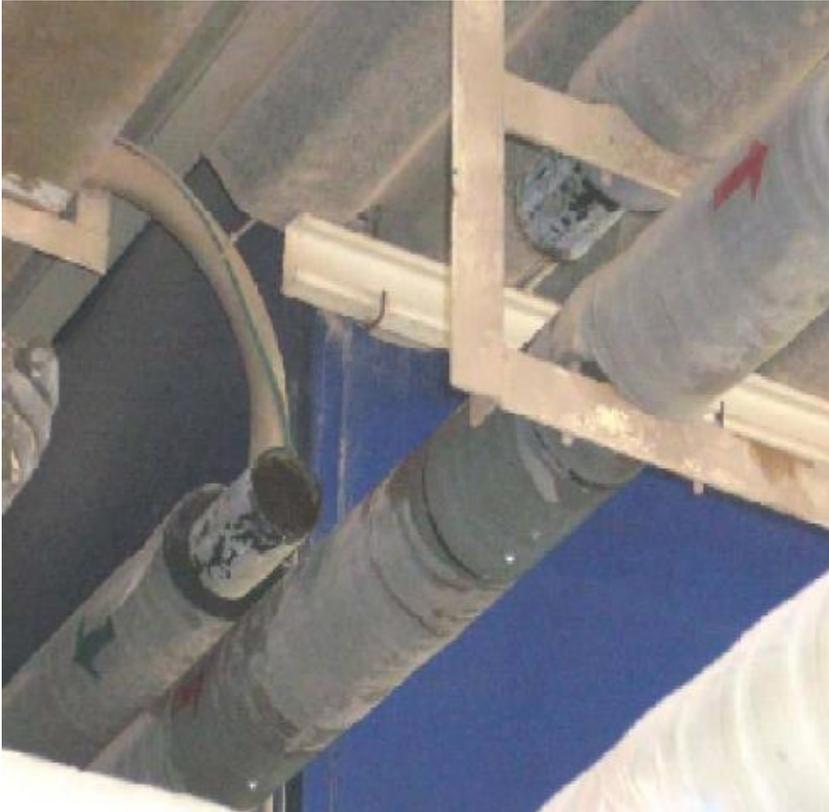
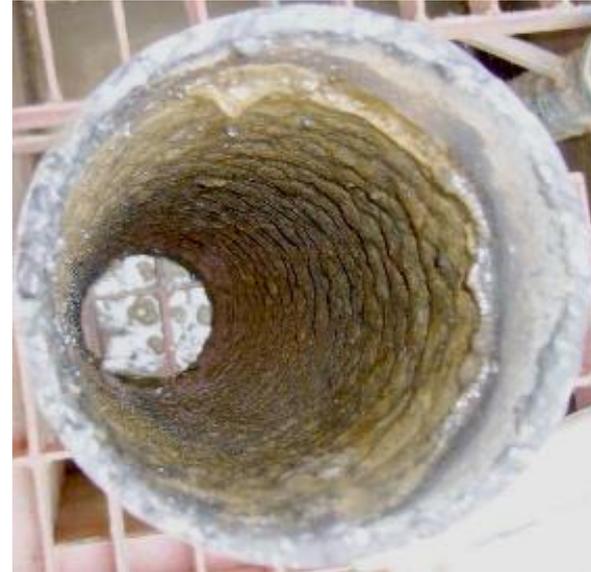
The thickness of scale inside the pipe was an average of 10mm decreasing the flow. The scale had also increased the weight of the pipe and, with much of it being installed on the ceiling, there were concerns that it could become unstable with the potential danger of it collapsing.

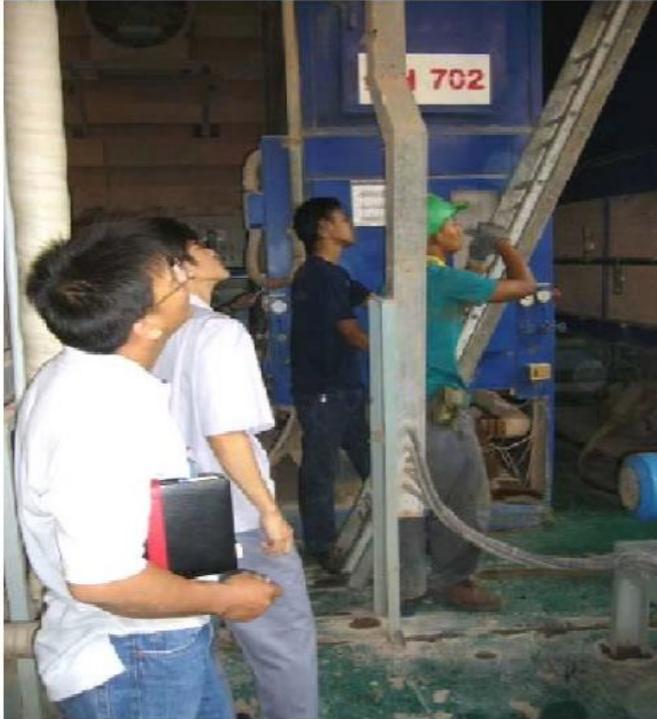
The MagCat was installed on a trial basis for 137 days and was removed for inspection under supervision the the head engineer of TCC.

This was the first time that the pipe had been inspected since the unit had been installed.

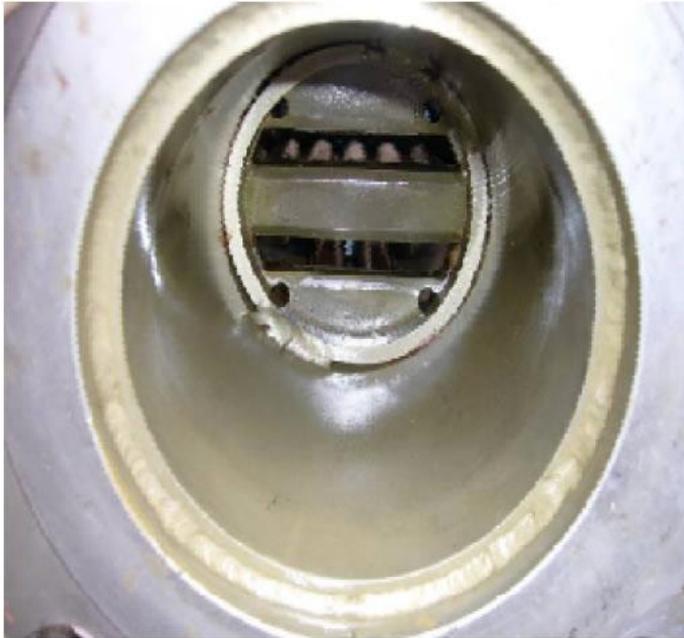
The MagCat was removed and inspected for fouling. There was no build up of any solids, just a coating of oil inside the unit.

This proved the water is heavily soiled with oil.

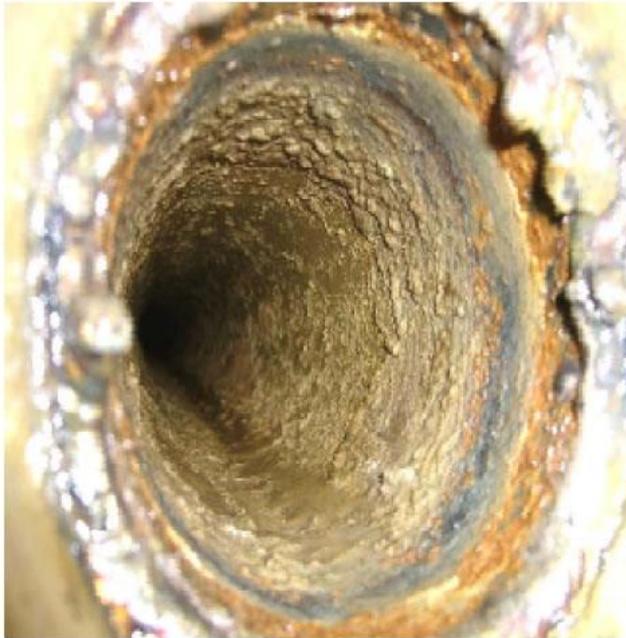
Once the MagCat was removed it was clear that the MagCat was having a considerable effect on the system. The scale thickness had decreased from 10mm to 3mm, a drop of 7mm.

Already in some places the bare metal has been revealed showing the considerable benefit since installation.
