Case Study

Honda (Thai)

Colloid-A-Tron Treatment for
Compressor After-Coolers

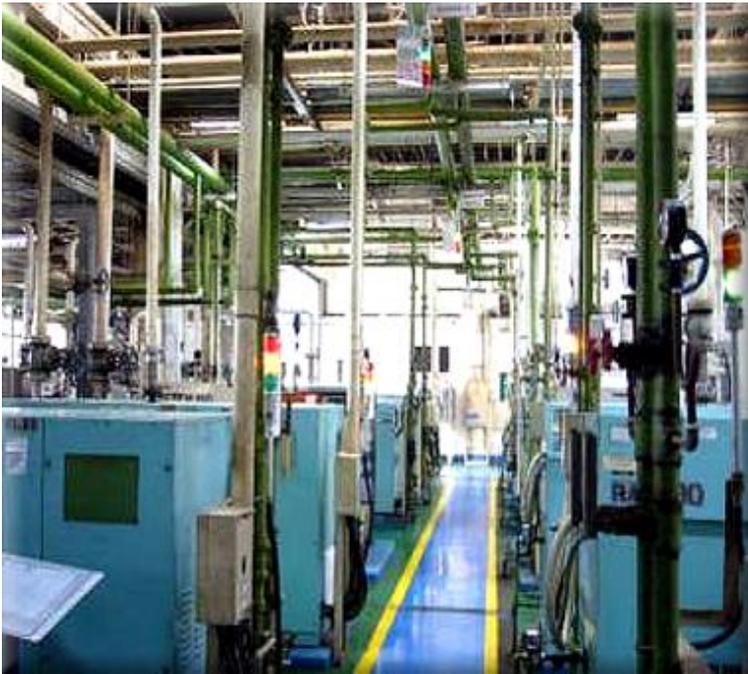
A series of 220 KW air compressors and air dryers generating compressed air which is used to power various equipment throughout the plant.

Due to the energy produced the equipment generates a large amount of heat and cooling water is continuously circulated through the equipment to control the temperature.

Compressors & Air Dryers at Thai Honda

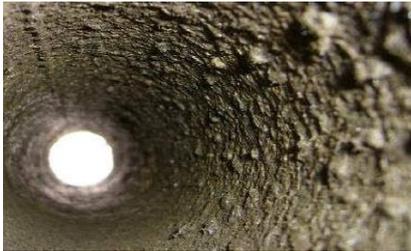
Feed Line to compressors
with scale deposition

Despite a costly softening and chemical dosing system treating the water before it is used for cooling, pipelines and the compressors were suffering from scale deposition.

The compressors required regular maintenance to remove the scale deposits and there were considerable pressure losses throughout the system due to scale build up.

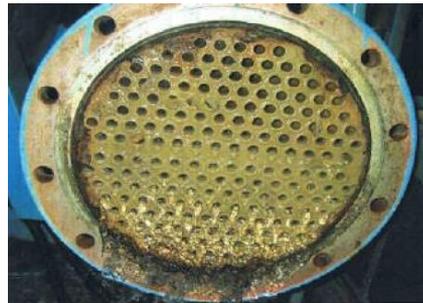
Compressor after cooler
with scale

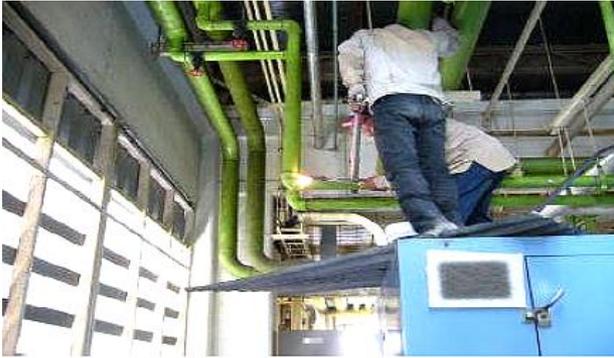
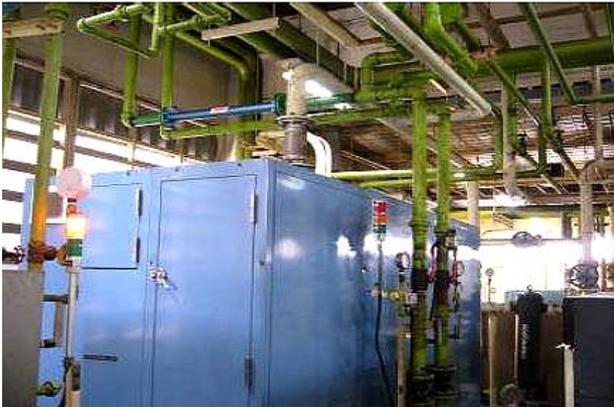
One of the compressors was chosen for the purposes of a trial to assess the performance and impact a Colloid-A-Tron would have in this system.

On November 21st the Colloid-A-Tron was installed on the feed line to the compressor under the supervision of Honda's staff.

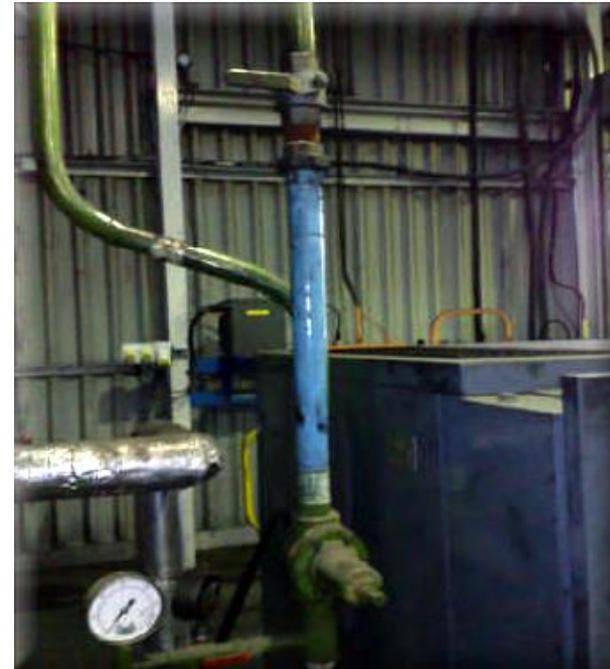
Columbian Chemical Installation

Prior to installing Colloid-A-Tron's in the compressor circuits, Colombian Chemicals had to clean their compressors twice every month to remove the deposition of scale. Since the installation of a number of units their compressors have been running totally scale free. The first unit installed was a 3" Colloid-A-Tron followed by a 1½" Colloid-A-Tron the following year. A further three units were installed including 2 x 1½", 1 x 1" and 1 x 1¼ Colloid-A-Tron units.

The most recent unit commissioned in 2008 was a 4" Colloid-A-Tron which is a testament to the success and longevity of the treatment on the compressors. Since installation of the first unit not a single compressor has required shutdown for cleaning. One compressor was run as a trial with no treatment for a short period and within six weeks the compressor required a shut down for de-scaling.
